Subject: EPA Comments on Dynegy Midwest Generation Inc. – Hennepin Power Station, Hennepin, IL  
Round 10 Draft Assessment Report

**RE: DMG Comments on Draft Assessment of Dam Safety of Coal Combustion Surface Impoundments at the Hennepin Power Station, dated March 15, 2012**

CLIENT Dynegy - Hennepin Power Station  
PROJECT NUMBER 082-255

PROJECT NAME Dry Ash Landfill Feasibility Study  
PROJECT LOCATION Hennepin, Illinois

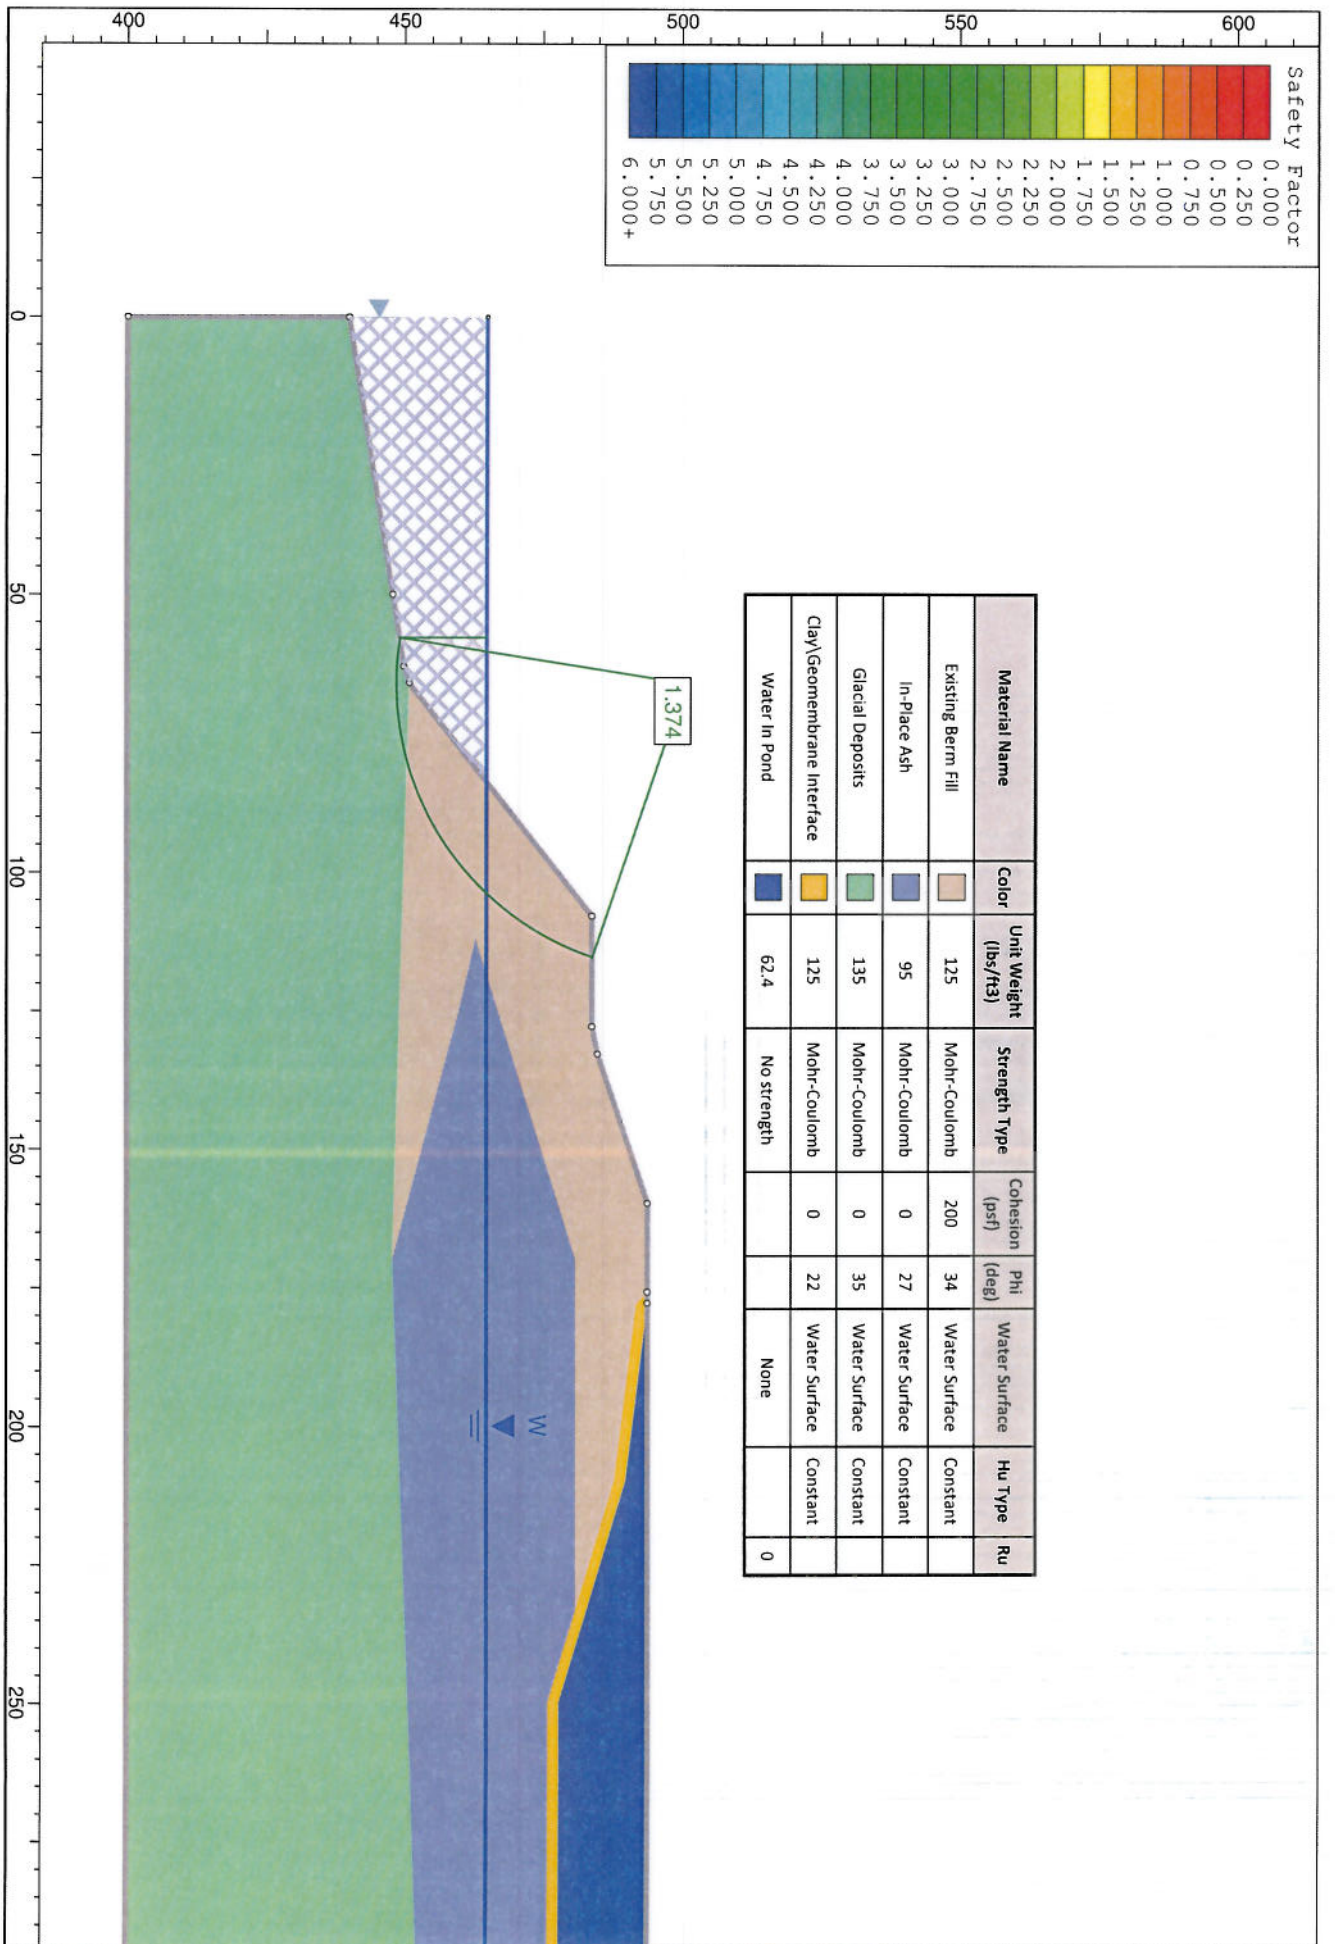
CEC performed a revised stability analysis for Section P2-1 utilizing more realistic effective shear strength parameters for the existing berm fill ( $\Phi' = 34^\circ$ ,  $c' = 300$  psf). These parameters are more consistent with the conditions encountered in the test borings at the site. Utilizing these parameters yields a FS = 1.37 and 1.24 for static and seismic conditions, respectively (see attached stability analyses).

1.239
